Tsunami vulnerability of buildings and people in South Java – field observations after the July 2006 Java tsunami

S. Reese¹, W. J. Cousins², W. L. Power², N. G. Palmer², I. G. Tejakusuma³, and S. Nugrahad³

Abstract. A team of scientists from New Zealand and Indonesia undertook a reconnaissance mission to the South Java area affected by the tsunami of 17 July 2006. The team used GPS-based surveying equipment to measure ground profiles and inundation depths along 17 transects across affected areas near the port city of Cilacap and the resort town of Pangandaran. The purpose of the work was to acquire data for calibration of models used to estimate tsunami inundations, casualty rates and damage levels. Additional information was gathered from interviews with eyewitnesses.

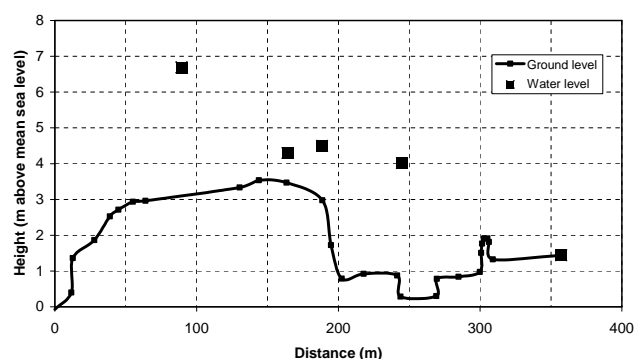
Fig. 2. Ground profile and flow depths measured at Widarapayung (Transect 1).

Elevation and depth measurements (Transect 1) were taken here. The sand dune beneath the pool complex was about 150 m wide and rose to a height of about 3.5 m above mean sea level (m.s.l.) (Fig. 2). The inland edge of the dune fell sharply to paddy fields about 1 m above m.s.l., then a further 0.5 m to a sluggish river running parallel to the beach for several kilometres. The tsunami flooded the paddy fields and river, and the subsequent rapid drainage washed away the approaches to a bridge across the river. Inland of the river there were more paddy fields that had been lightly inundated up to about 50 m beyond the river, giving a total inundation distance of about 350 m. There were extensive deposits of fresh sand on the sand dune (measured between 14 and 25 cm; Fig. 3), often covering low vegetation and ground litter, and deposits of compacted sandy silt in the paddy fields between the dune and the river. The crops in those paddy fields had been destroyed.

Figure 2 (above) shows the ground profile and estimated flow depths at Widarapung. Zero distance represents the edge of the sea at the time of the profile measurement. At this location the beach was about 40 m wide. Except the urban areas most of the transects typically followed the same profile. There was usually a gently sloping beach, followed by relatively flat sand dune 200 to 400 m wide (bearing houses and trees), and then a steep descent to lower-lying paddy fields. At Widarapung the topography was slightly different due to a river that cut through the fields.

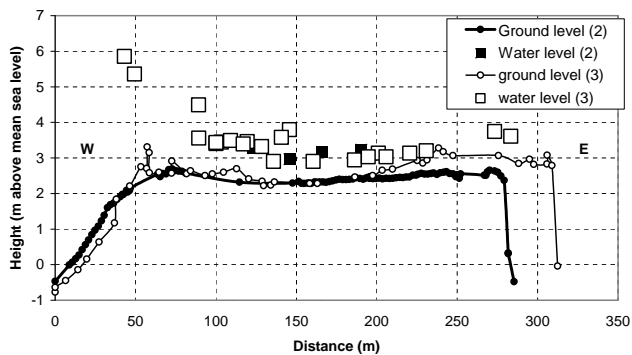
Fig. 7. Ground profile and estimated water levels of transect 2 & 3 in Pangandaran. The steep drop at the right-hand (east) side is a sea wall at the eastern end.

The next example (Fig. 7, Transects 2 and 3) is from urban locations in Pangandaran. According to eye-witnesses the tsunami struck the western part of the peninsula first (about 16:19 LT), travelled around the tombolo, and hit the eastern part of the peninsula about 1 min later. This is consistent with Lavigne et al.'s (2007) observations. According to eye-witnesses, the water met not exactly in the middle but slightly further east around 200 m from the western beach, because of the time delay of the eastward wave. These observations are reflected in our inundation graphs which indicate a minimum water depth at about the 200 m mark.

The maximum measured wave height and flow depth for Transect 2 were 3.27 m and 0.95 m, respectively, and 5.86 m and 3.10 m for transect 3. These seem to correspond with the survey results from Lavigne et al. (2007) and Tsuji et al. (2007). Note also the very rapid decrease in water depth, from about 3 m to less than 1 m, in a distance of about 100 m.

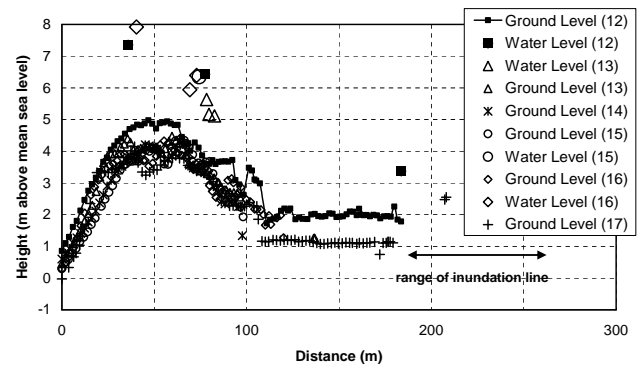
Fig. 8. Ground profiles 12–17 and water levels throughout Batuhiu.

Profile 12 was at the easternmost end, profile 17 at the westernmost (Fig. 8). There was a steady decrease in height of the entire ground profile, by about 1 m, from east to west. Profile 12 traversed the dune then crossed paddy fields to an “island” in the paddy fields, while profile 17 traversed the coastal dune then paralleled a road through the paddy fields. The remaining profiles terminated at the inland edge of the

coastal dune. All the measurements show the same pattern with the maximum water level around the dune crest (e.g. 7.9 m, flow depths 3.7 m along transect 16), decreasing to 2 m around the buildings and 1 m in the paddy fields. The Inundation line was observed to lie between 260 m (transect 12) and 180 m (transect 17).

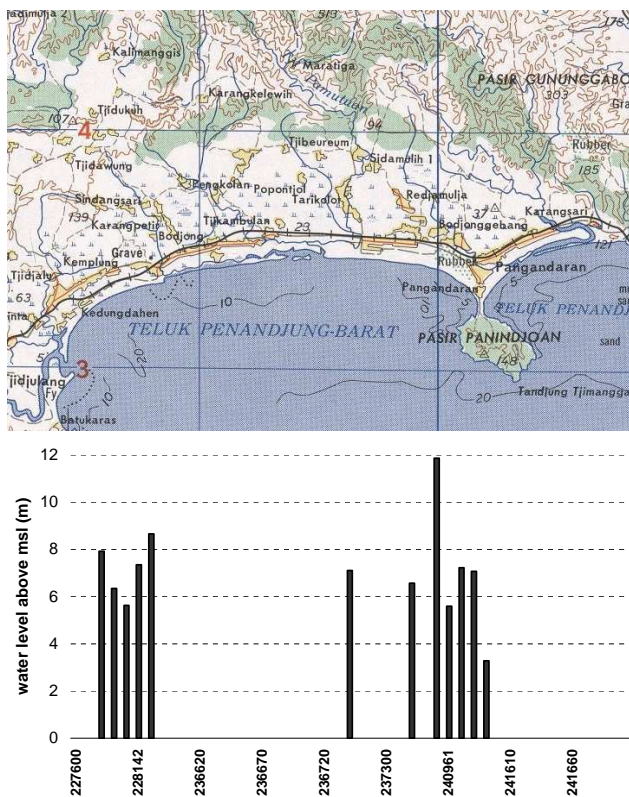
Fig. 9. Maximum observed water levels in the Pangandaran area.

Along the coast in the Pangandaran district the maximum water levels ranged from 3.3 m in the sheltered areas close to the Pangandaran peninsula, to 11.9 m in Pananjung Village (Fig. 9). The water height of 11.9 m (above m.s.l. – corresponding to a depth of about 9 m above ground level) was an observation made by the manager of a hotel in relation to palm trees between the hotel and the sea. It is much higher than all other estimates and so, assuming that it is as reliable as the others, must have been a localised phenomenon. The

fact that other teams did not measure water levels of this dimension in this area might argue for an overestimation. Our other levels are in line with the measurements from Lavigne et al. (2007) and Tsuji et al. (2007).

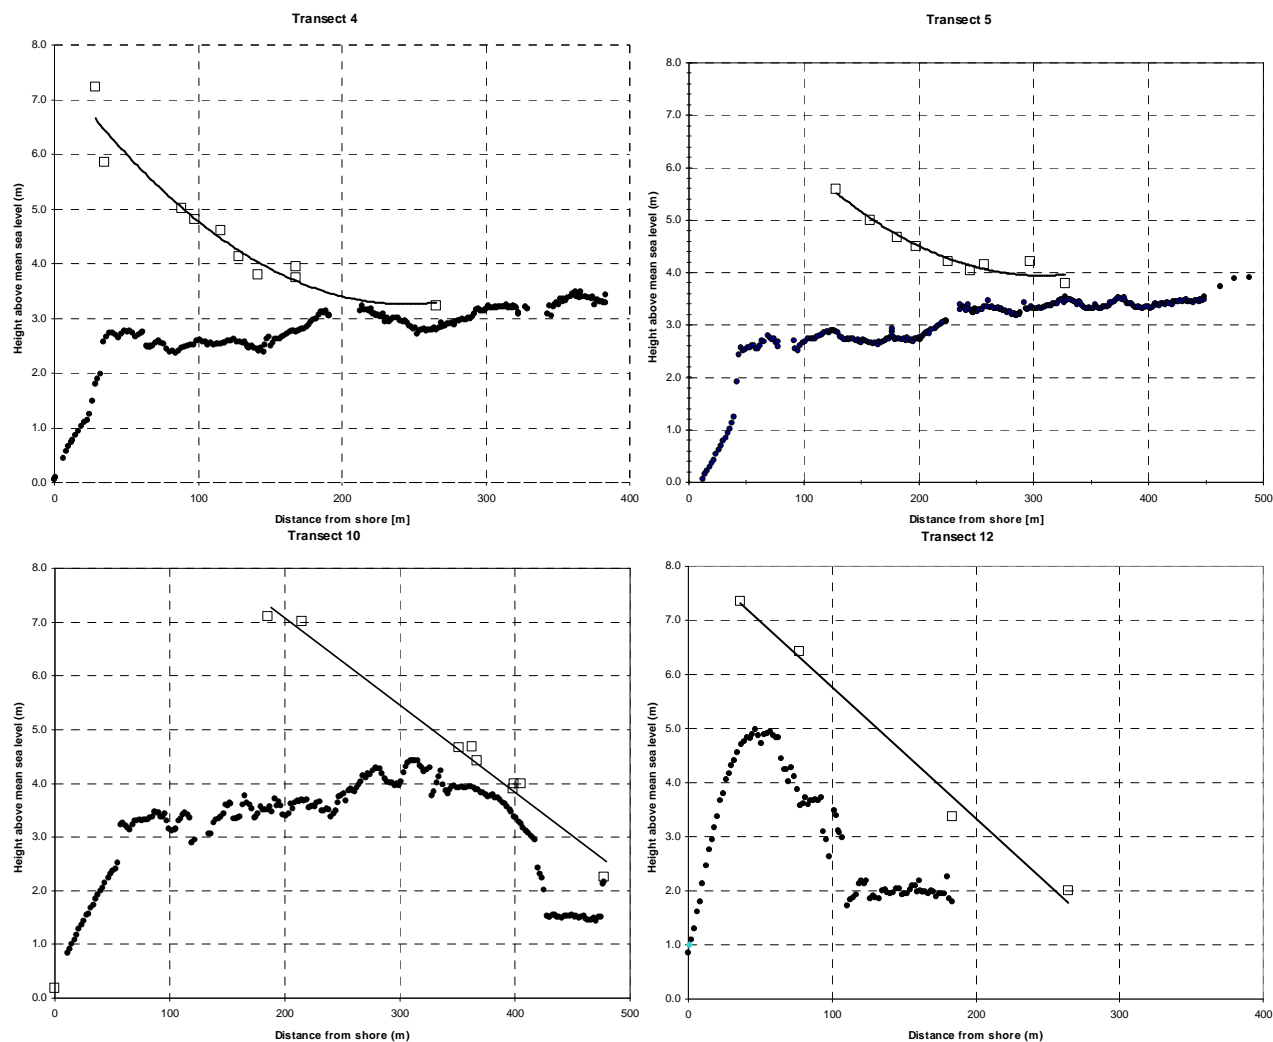
Fig. 10. Decay of on-shore water level.

Comparing the various ground profiles and wave height measurements shows how the on-shore topography affects the flow of the tsunami wave. By taking the wave heights/water levels and adding a trend-line reveals two different patterns, a linear and an exponential decay of the water level (Fig. 10).

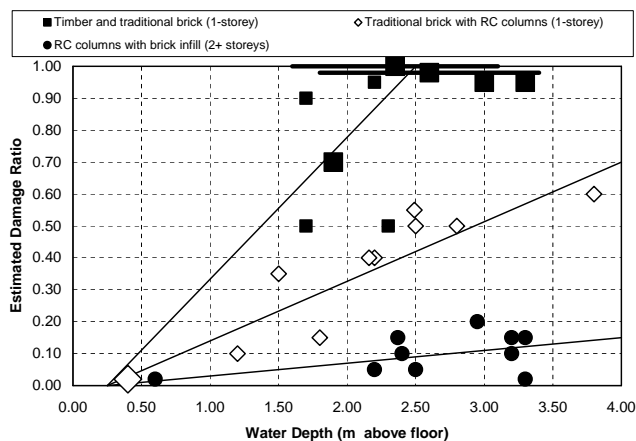
Fig. 15. Estimated damage ratios and fragility curves as a function of inundation depth for various types of Pangandaran buildings. The large symbols represent averages from large groups of buildings (60 or more) that had relatively uniform levels of damage, and the small symbols one to few buildings. Two of the large symbols are associated with ranges in water depth indicated by horizontal bars. A damage ratio of 0.9 indicates that the concrete floor was potentially reusable, 1.0 indicates that the area had been bulldozed clear.

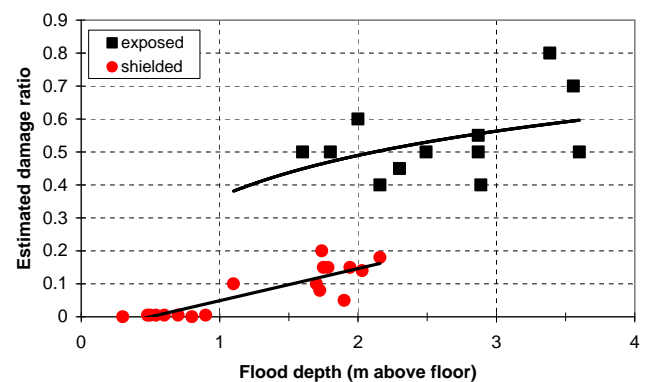
Fig. 16. Damage ratios and fragility curves as a function of inundation depth and exposure for traditional brick buildings with RC columns.

made of brick with RC columns sustained damage not greater than 20%, similar exposed buildings all suffered damage above 40% and were exposed to greater flood depths (Fig. 16). Thus, these buildings need to be separated and accordingly two different fragility curves are required. A regression analysis suggests two completely different shapes. For the exposed buildings a logarithmic shape fits best while for the shielded buildings an exponential shape seems more appropriate.

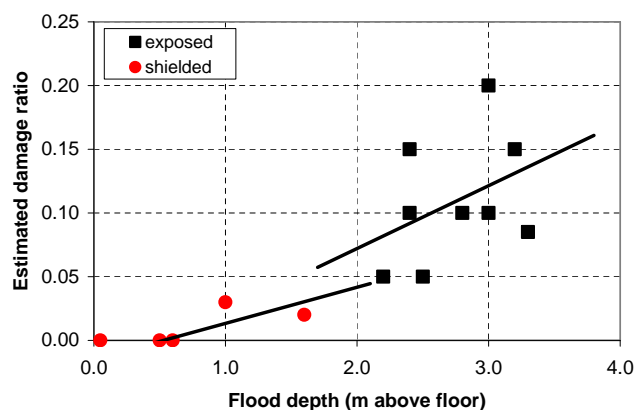
Looking at the well-constructed, reinforced buildings under this perspective doesn't show a clear trend as before (Fig. 17), but it is likely that this is due to the smaller number of samples. Nevertheless, a difference in the level of damage is still visible. The exposed buildings have sustained damage levels 2 to 5 times higher than the shielded ones.

Fig. 17. Damage ratios and fragility curves as a function of inundation depth and exposure for buildings made of RC columns with brick infill.

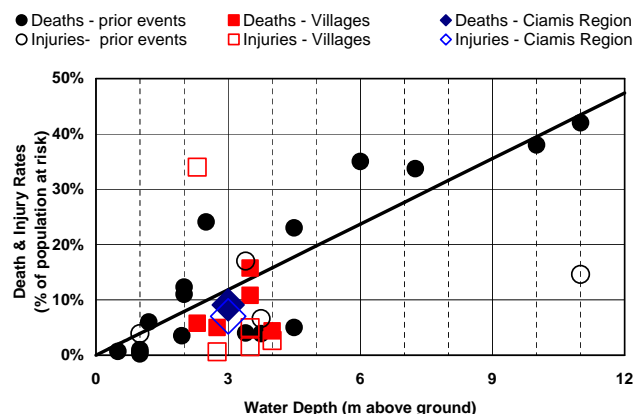
Fig. 18. Death and injury rates as functions of water depth. The trend line is fitted to the death data from prior events (Saunders (compiler) 2006).

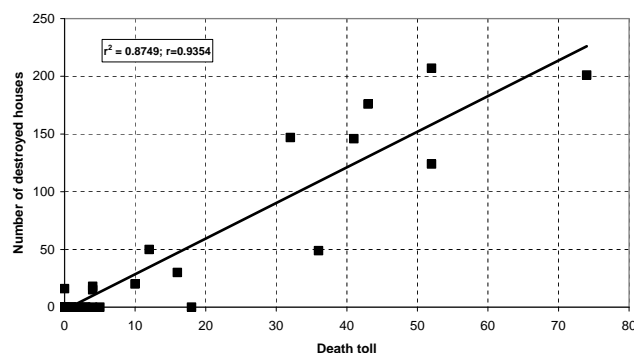
Fig. 19. Death rates as functions of building destruction.

More recently there has been a tendency to relate casualties to levels of damage. The detailed Java data enabled us to analyse the data regarding a possible correlation between the death toll and the number of houses destroyed. There appeared to be a clear correlation between the two parameters (Fig. 19), possibly providing a way of estimating casualties when direct counts are not available.
